Town of Arlington Community Preservation Act Committee

Final Application for FY20 CPA funding

OLD BURYING GROUND & TOMBS AT MOUNT PLEASANT CEMETERY PRESERVATION PLAN

ARLINGTON, MASSACHUSETTS

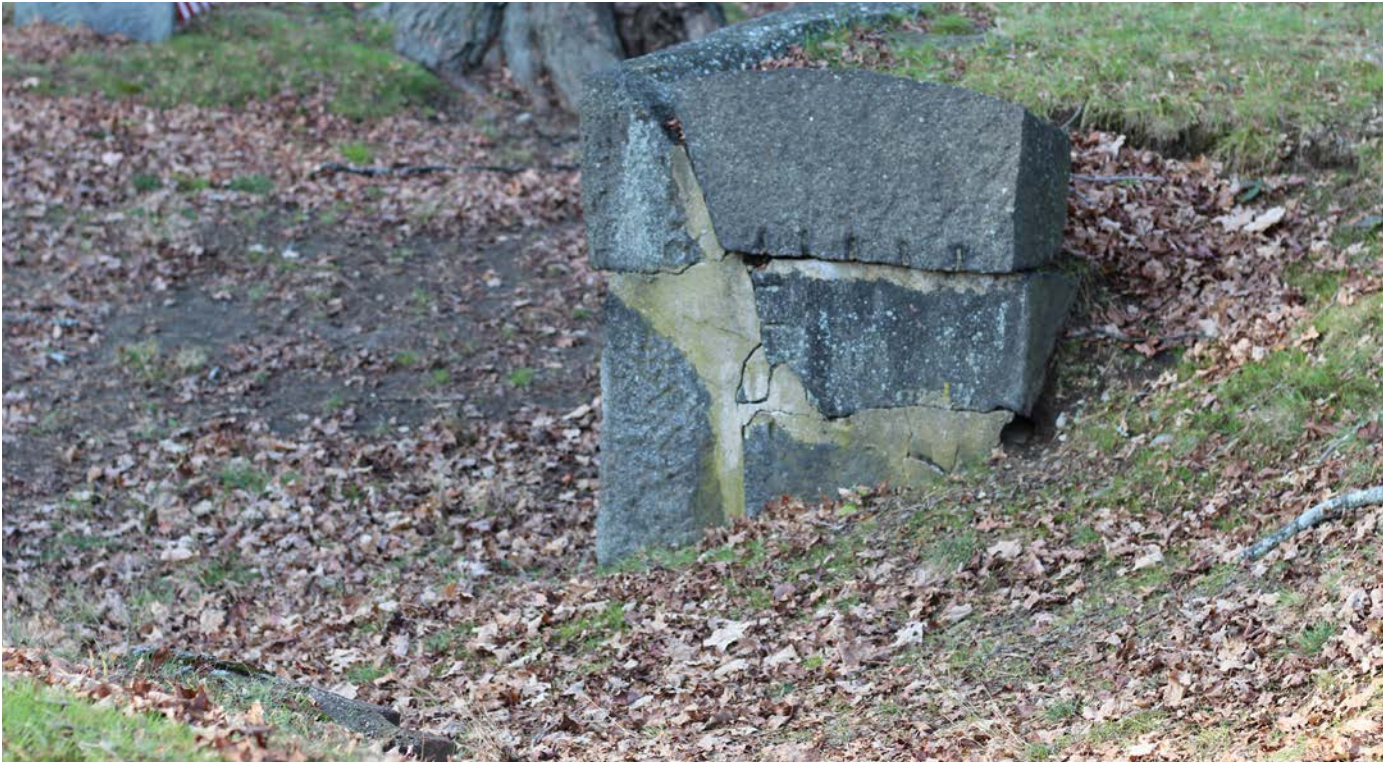
Masonry Side Walls of OBG Northeast Tombs Have Shifted

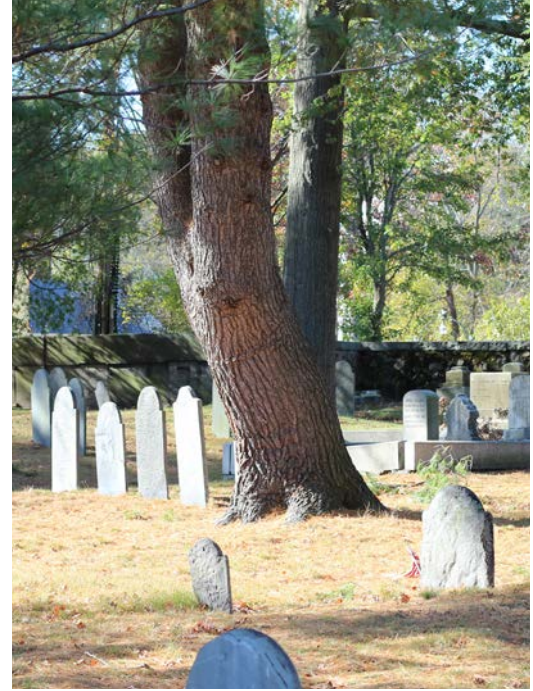
OBG Lawn in Poor Condition

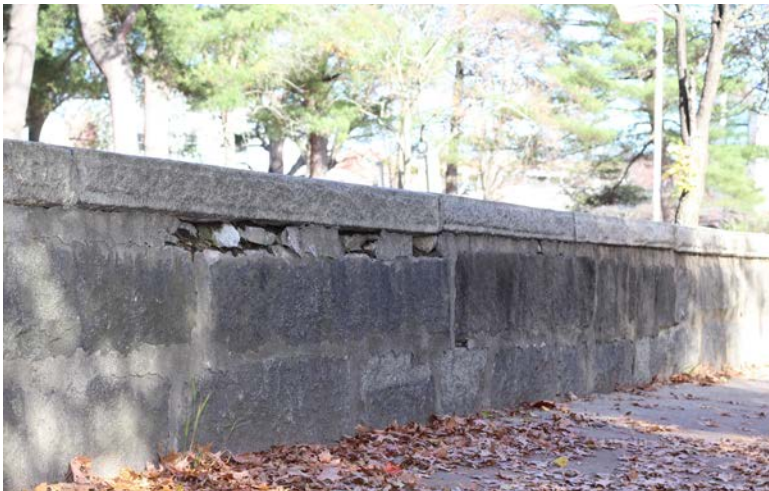
4. Pleasant Street wall - mortar missing from joints

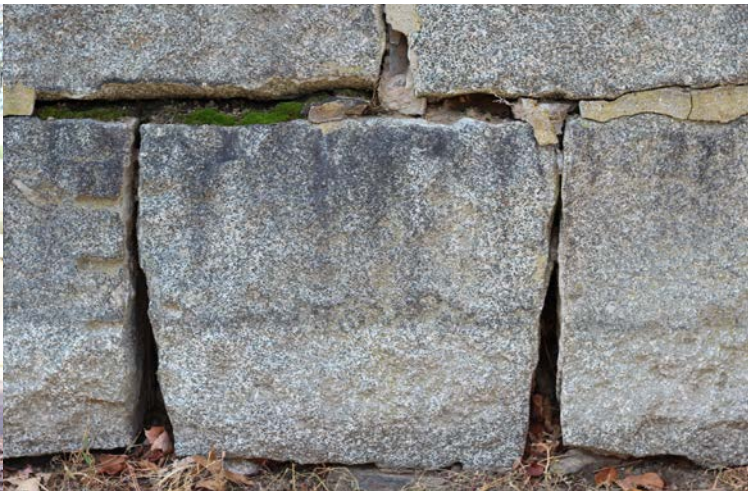
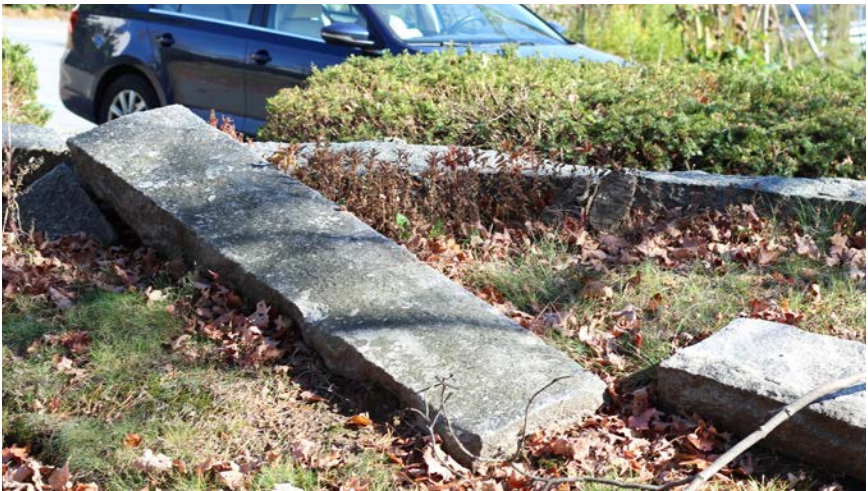
5. Coping stones lying next to wall

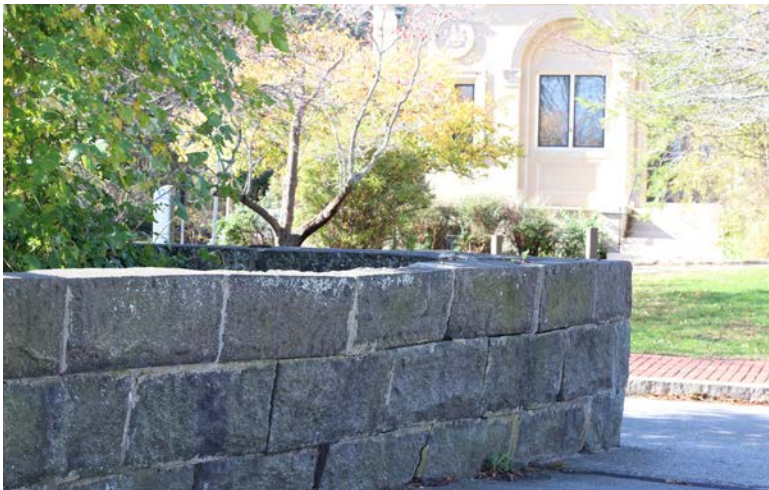
6. Northeast wall - stone, area of bulging

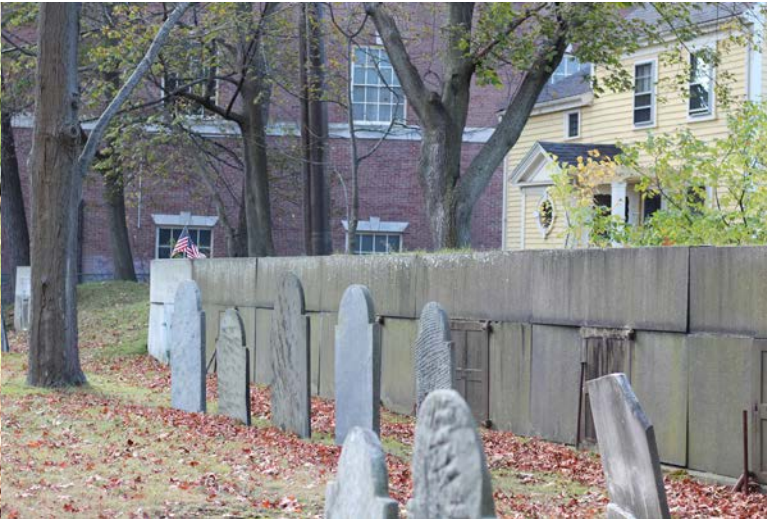
9. Peg Spengler Way wall - stone, moss growth

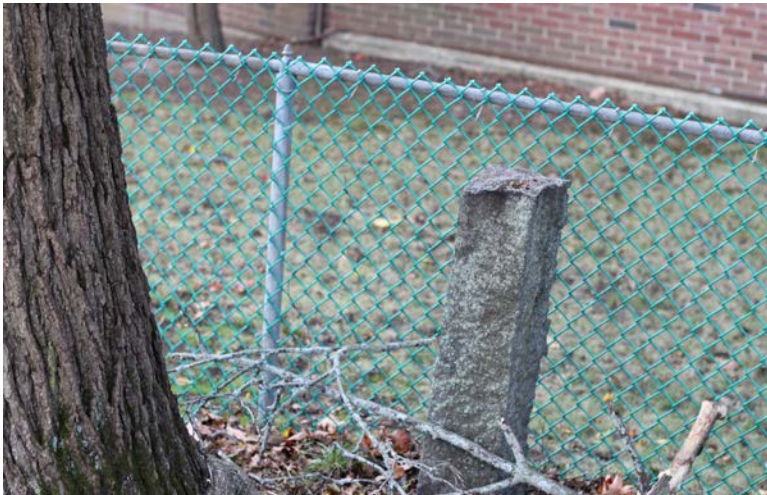
12. Granite posts, missing iron rail

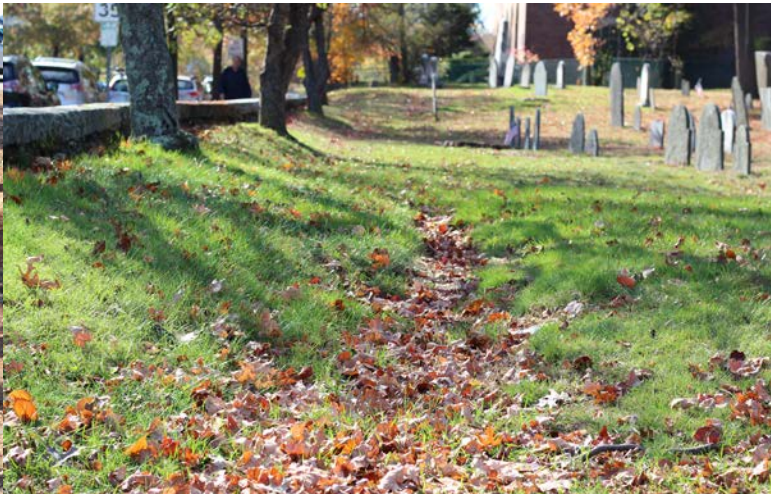
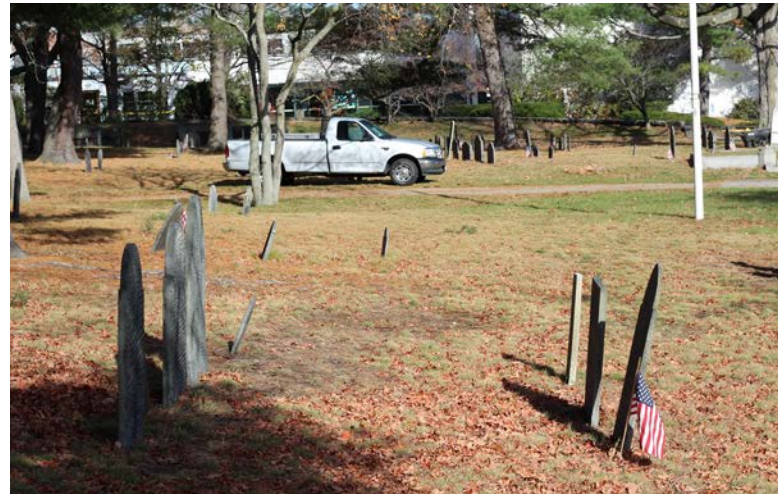
16. Bare lawn

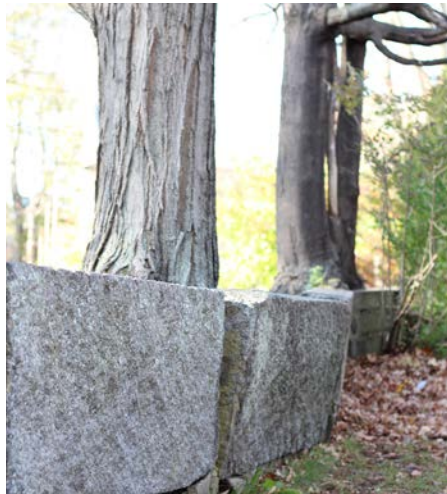
17. Trees growing into wall

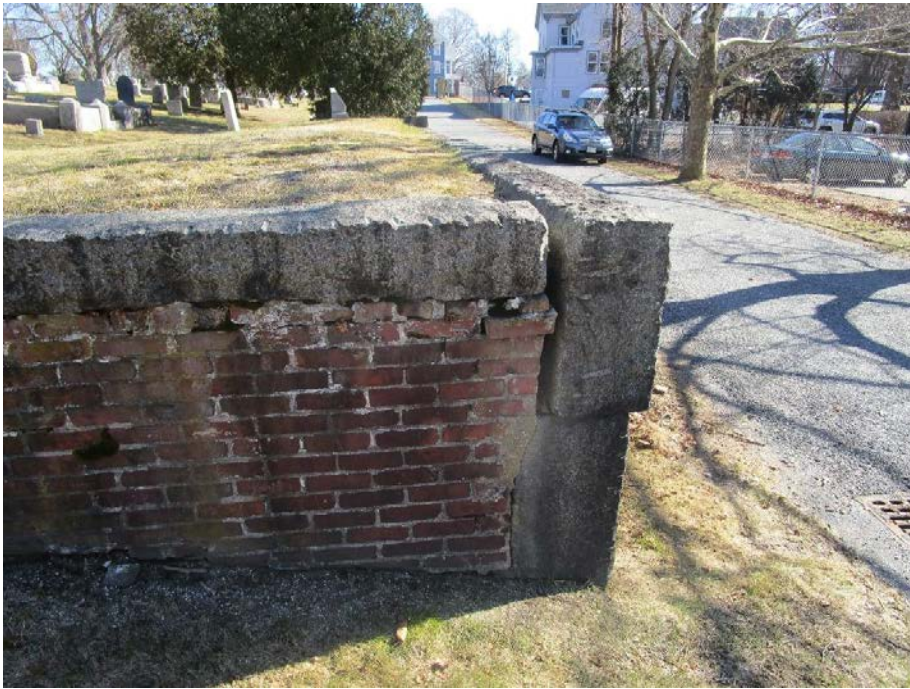
The brick retaining wall is leaning outward and the upper courses are debonded.

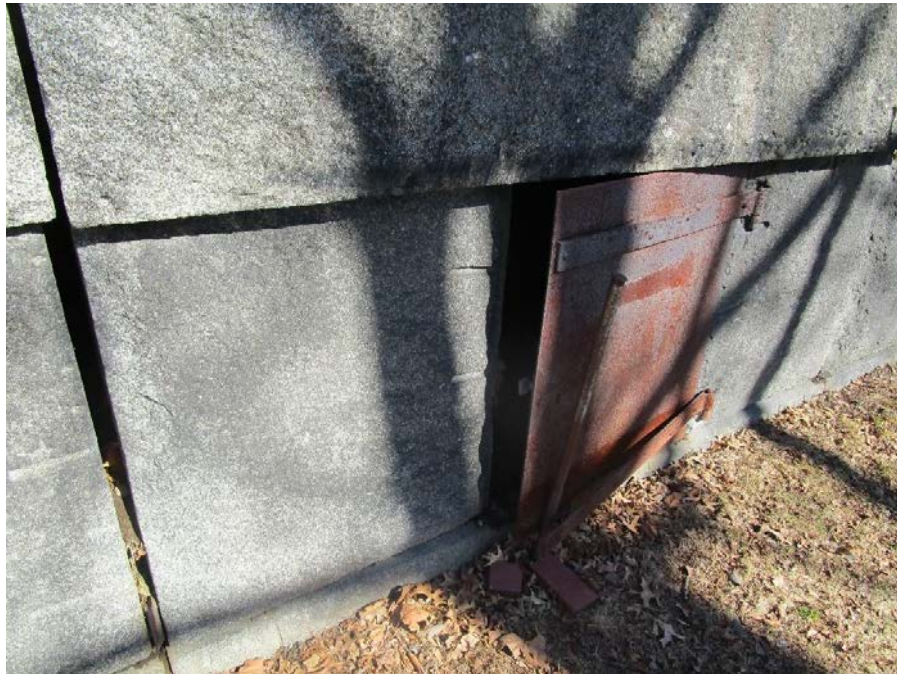
The metal doors are badly corroded and the straps securing them to the hinges are either missing or detaching from the sheet metal. The door closure system – a bar hammered into the ground is not very secure.
